Restoring Natural Systems to Solve Infrastructure Challenges

Presented to: The 2026 New Jersey Coastal and Climate Resilience Conference

- Case Study: I-895 Stream Restoration in Lansdowne, MD
- Ultra-urban watershed, aging culvert, critical rail crossing
- Nature-based retrofit for infrastructure protection
- Climate Resilience & Asset Management

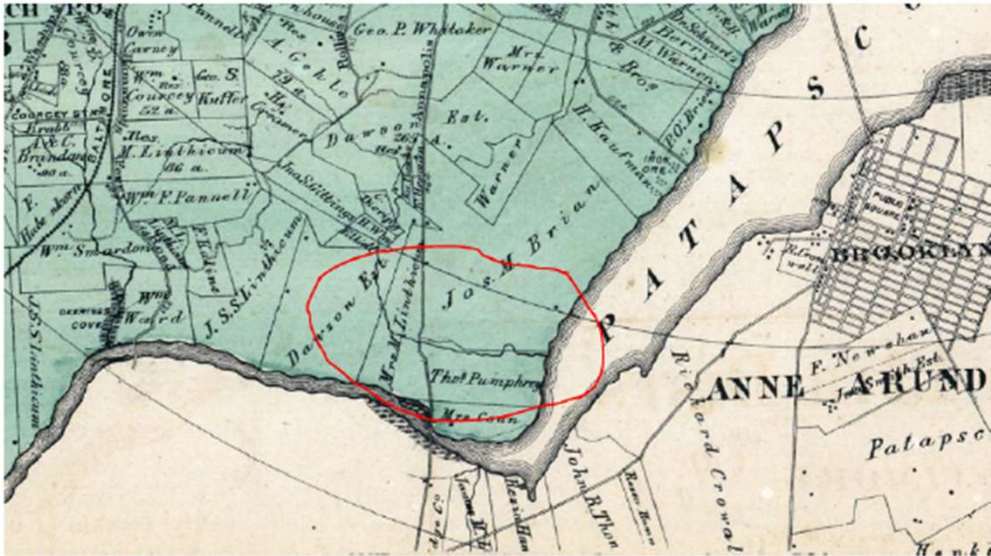
Figure 3: Map of Annapolis Road and the parcels at the project site circa 1878 (Hopkins).

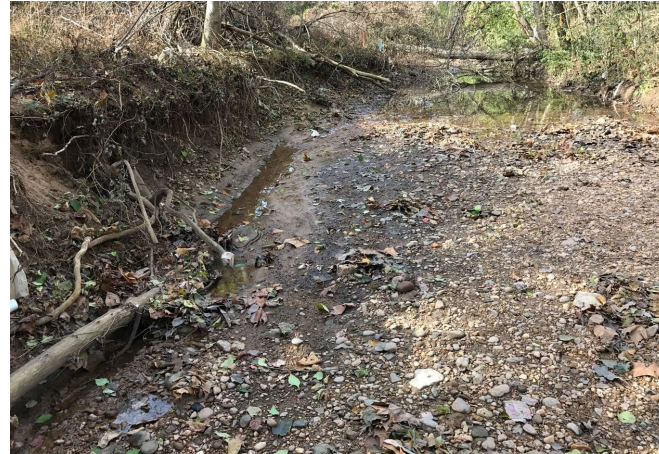
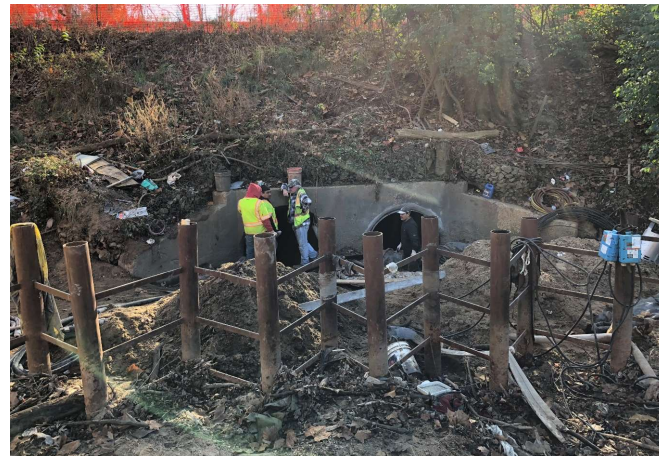
- ~60% impervious watershed
- Large portions of headwaters piped
- Sediment, woody debris and trash collect at the culvert
- Downstream culvert is undersized for present-day watershed conditions, but upsizing was constrained by a major water main above the crossing.

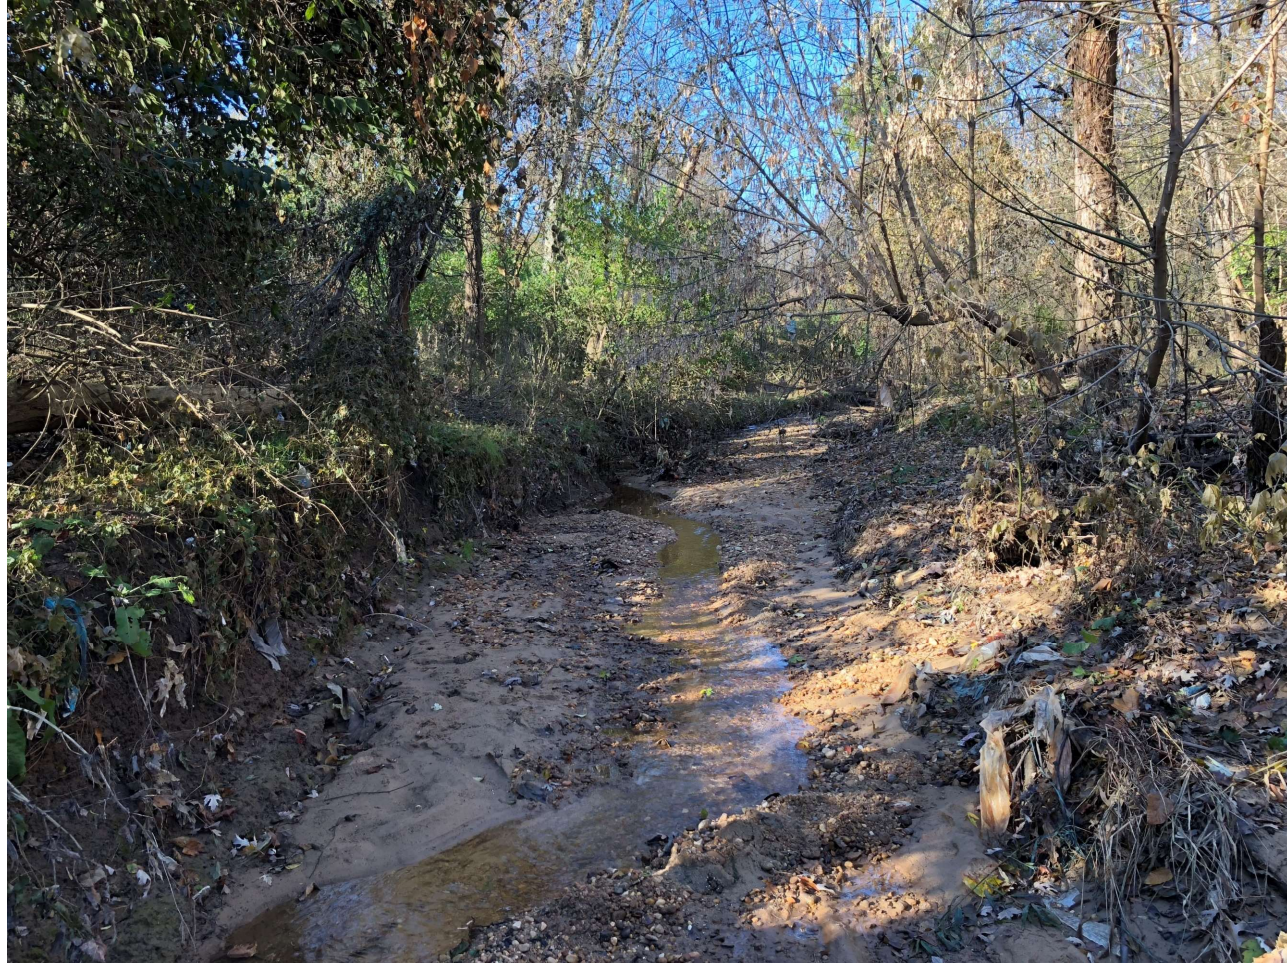
- “Just a drainage conveyance”
- Limited to no in-stream habitat
- Heavy sediment deposition and aggradation
- Flow disappeared below sediment surface in places
- Poor channel definition and degraded function

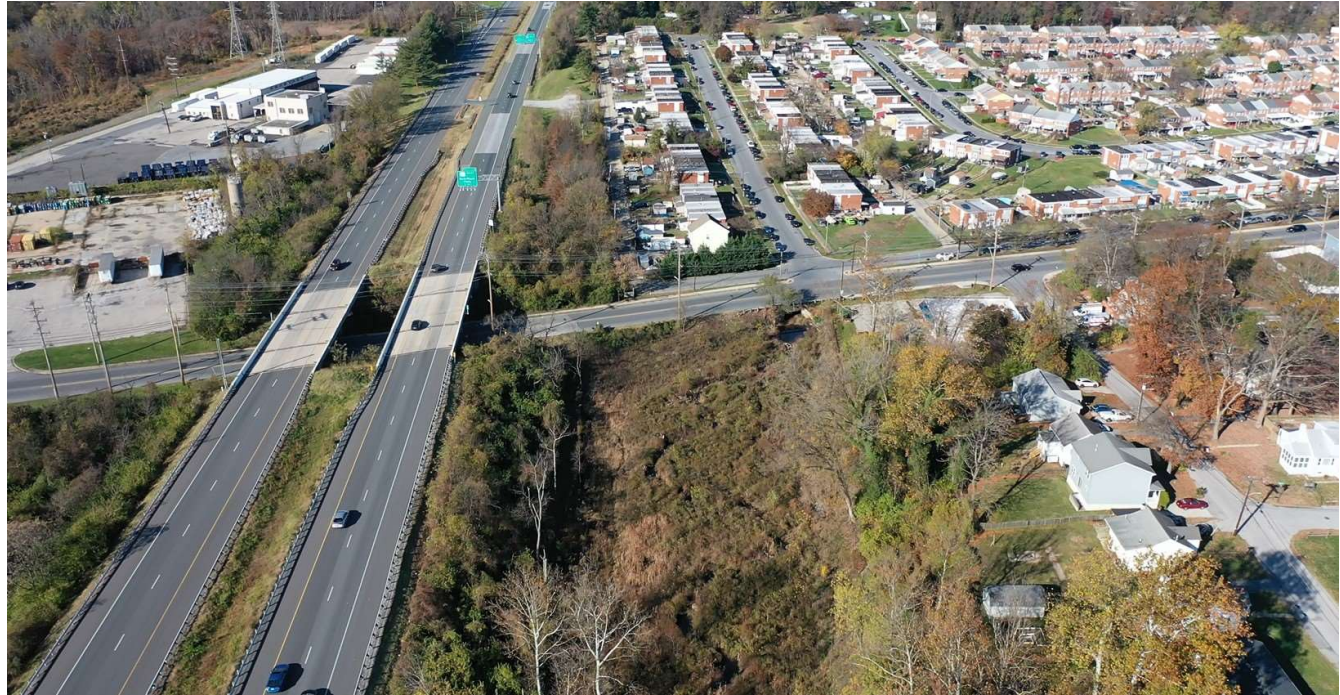
- Preferred strategy: modified floodplain restoration where constraints allowed
- Reconnect channel to low-elevation riparian floodplain
- Reduce flow depth and dissipate energy
- Capture sediment and nutrients before they reach the culvert
- Wood structures were able to be used in low stress areas

- Preferred strategy: modified floodplain restoration where constraints allowed
- Reconnect channel to low-elevation riparian floodplain
- Reduce flow depth and dissipate energy
- Capture sediment and nutrients before they reach the culvert
- Wood structures were able to be used in low stress areas

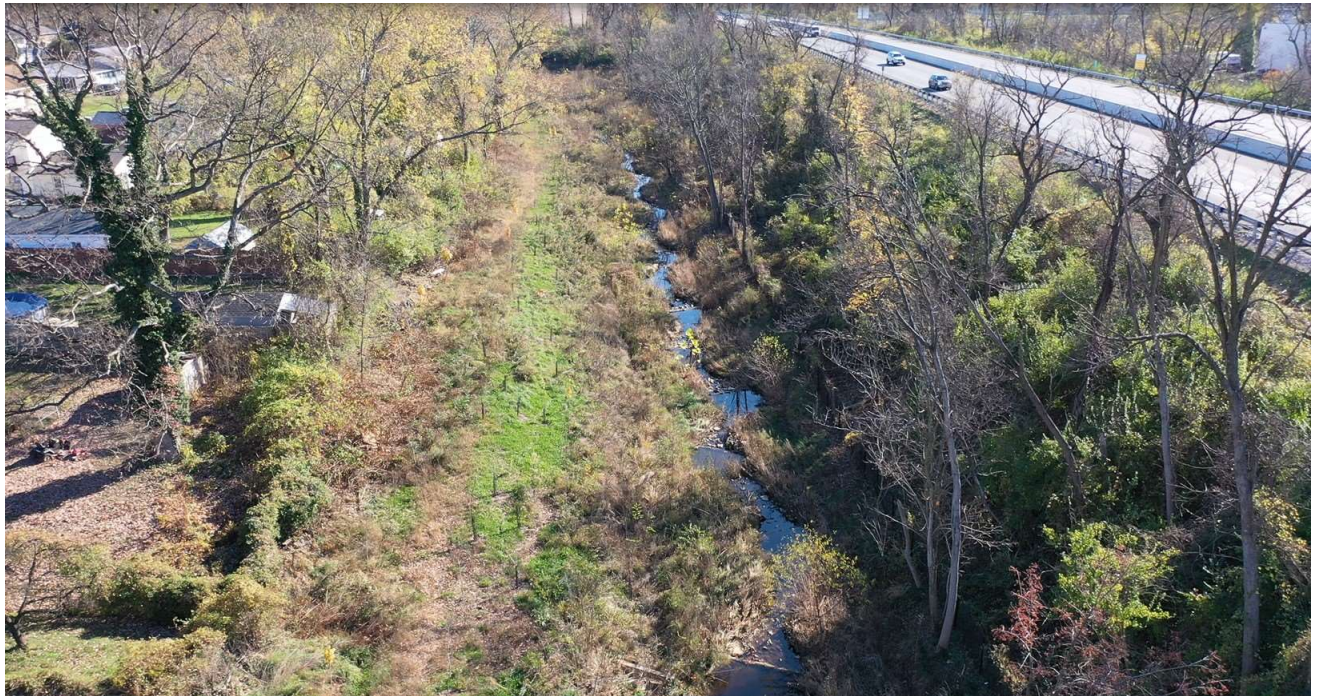
- Where the valley constricted, the design approach shifted closer to a step-pool system with limited floodplain access
- Rock structures and buried log vanes were used
- Elevations of multiple storm drain tie-ins drove stream profile
 - Pools were designed/sized for the stream system and as scour pools for storm drain tie-ins

- Where the valley constricted, the design approach shifted closer to a step-pool system with limited floodplain access
- Rock structures and buried log vanes were used
- Elevations of multiple storm drain tie-ins drove stream profile
 - Pools were designed/sized for the stream system and as scour pools for storm drain tie-ins

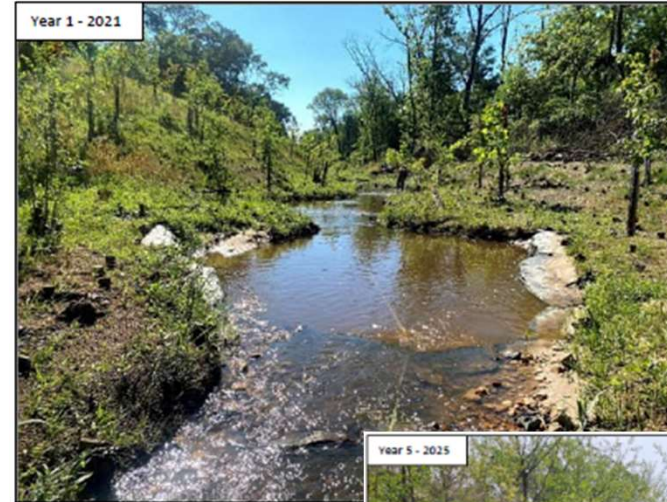
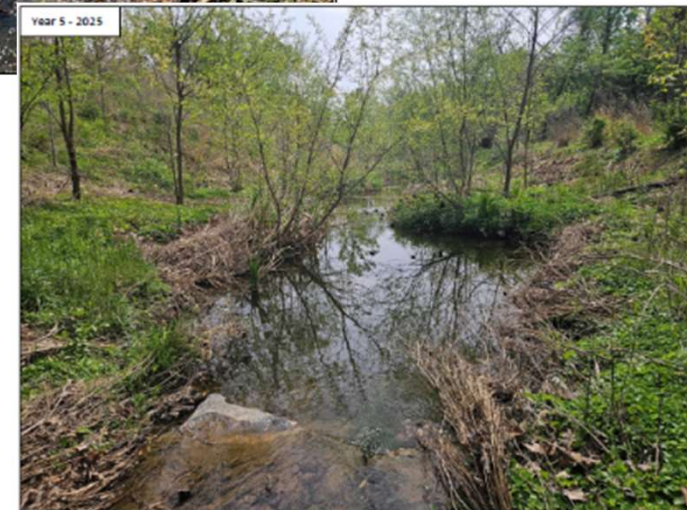
- Restored reach functioning as stream-floodplain system
 - Informal Client Feedback: “wetlands are developing even better than we imagined”
 - Informal Client Feedback : “no major problems but a lot of trash from storm events”
- Through 5 years of monitoring, all performance standards have been met/exceeded
 - 92% Native Species
 - 88% FAC, FACW, or OBL within the floodplain
 - 2025 saw a significant drought during the growing season, all groundwater wells held water within 24 inches of the surface
- Reduced maintenance at the culvert system

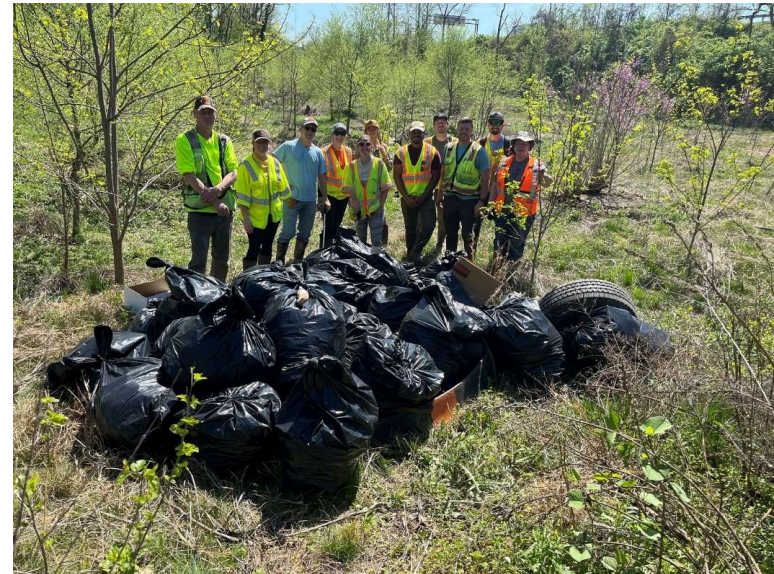
- Client continues to collect data on trash cleanup
 - April 2023 – Approximately 12 bags of trash removed.
 - April 2024 – Approximately 32 bags of trash removed, including 3 tires.
 - Early 2026 had a total of 29 contractor trash bags each weighing 30-35 lbs.
- Less trash is making its way to the trash rack
- MDTA has explored in-stream trash collectors
- Maintenance plan also includes invasive control, deer browse monitoring and storm checks
- Aggressive vegetation oversight
